# A Review of Australian and New Zealand Investigations on Aeronautical Fatigue During the Period April 2009 to March 2011

**Air Vehicles Division**  
Defence Science and Technology Organisation

DSTO-TN-0993

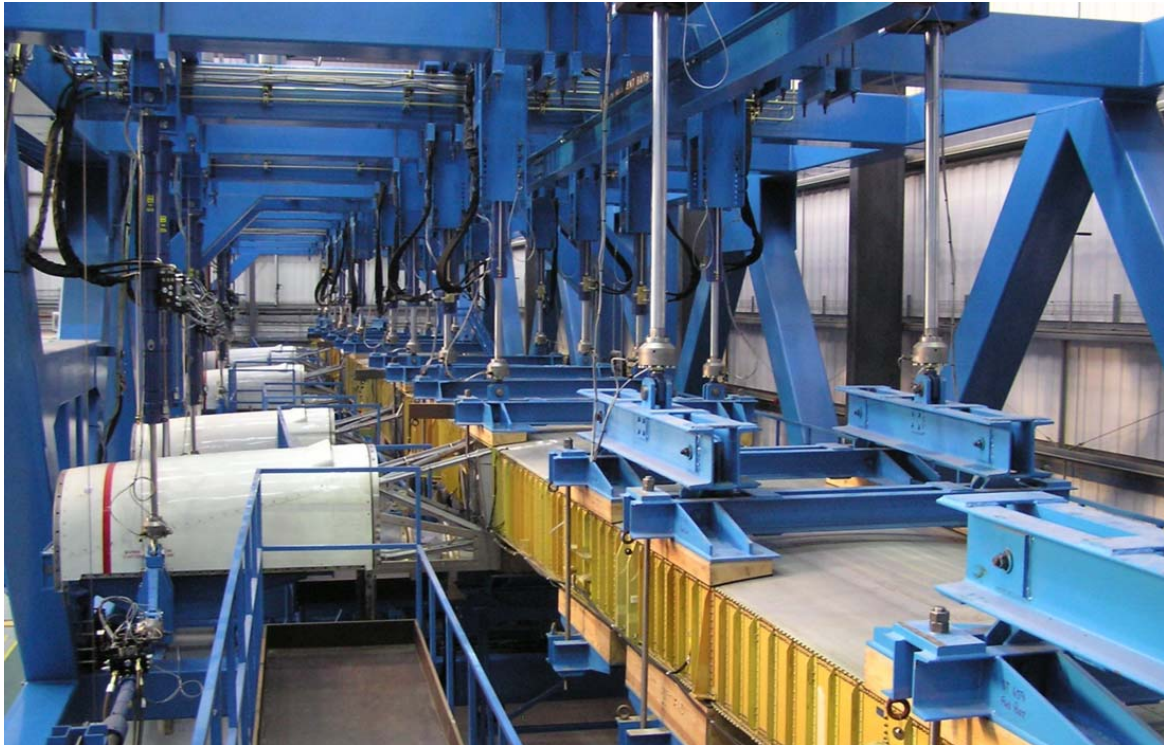
*Figure 1: Collaborative RAF/RAAF C-130J Wing Fatigue Test (Marshall Aerospace, Cambridge, UK)*

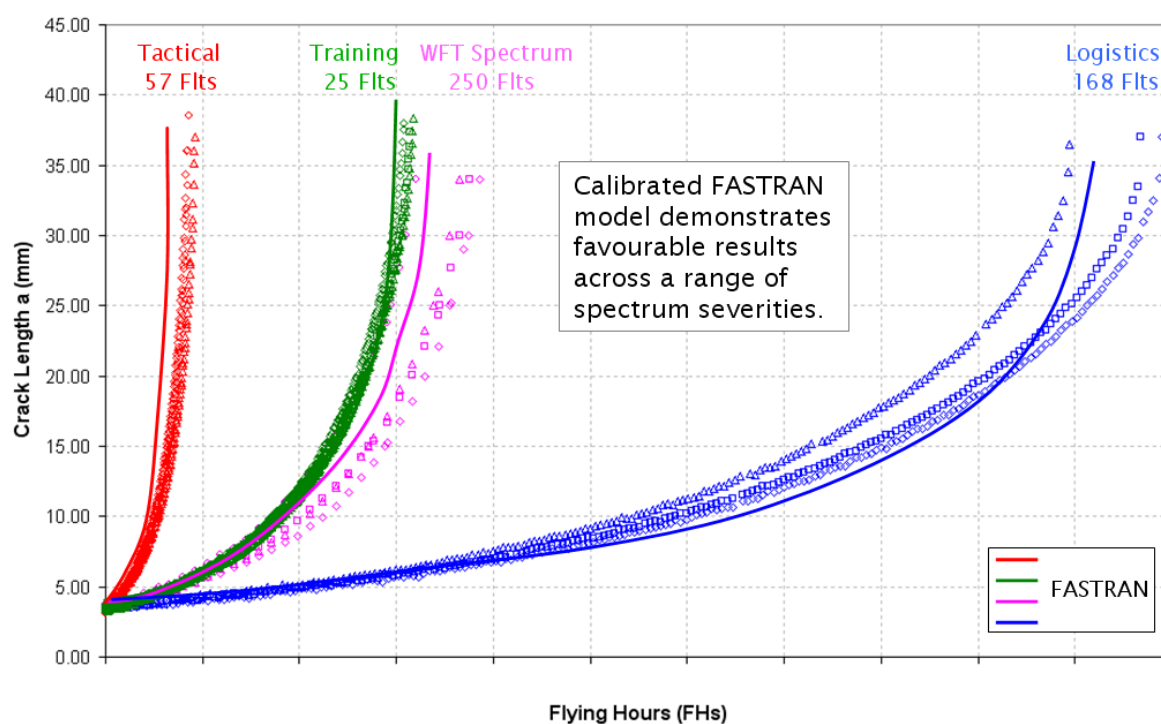
Figure 4: Wing Lower Surface Spectra Coupon Test (7075-T7351) vs FASTRAN Analytical Crack Growth Prediction (Various Spectra Severities)

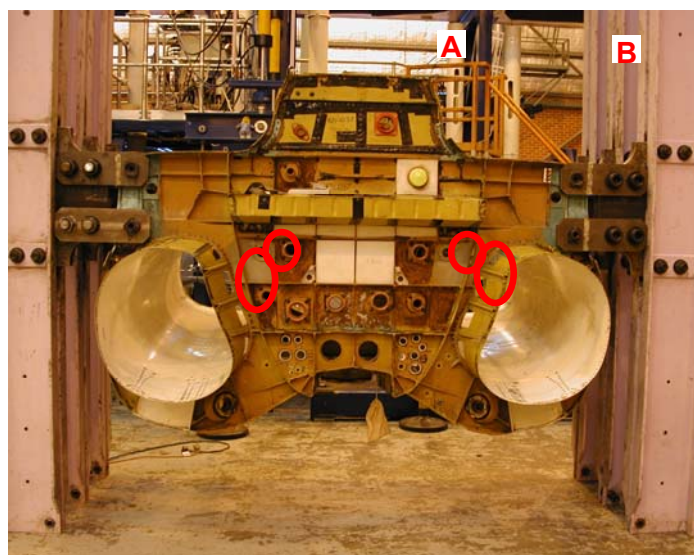
Figure 1: Locations (circled) on the Y453 bulkhead where a safe life extension was possible using DSTO’s novel lead crack concept methodology. View looking aft.

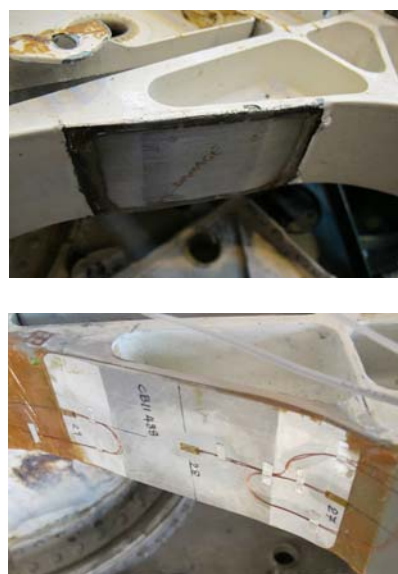
Figure 2: (Top) The OEM bonded aluminium doubler developed to address potential cracking on early configuration kick points (Point “A”). Point “B” indicates the point of stress concentration caused by the inboard end of the doubler on the kick point lower flange. (Bottom) The DSTO developed doubler which essentially extends the inboard end of the OEM doubler to cover the entire kick point pocket lower flange area.

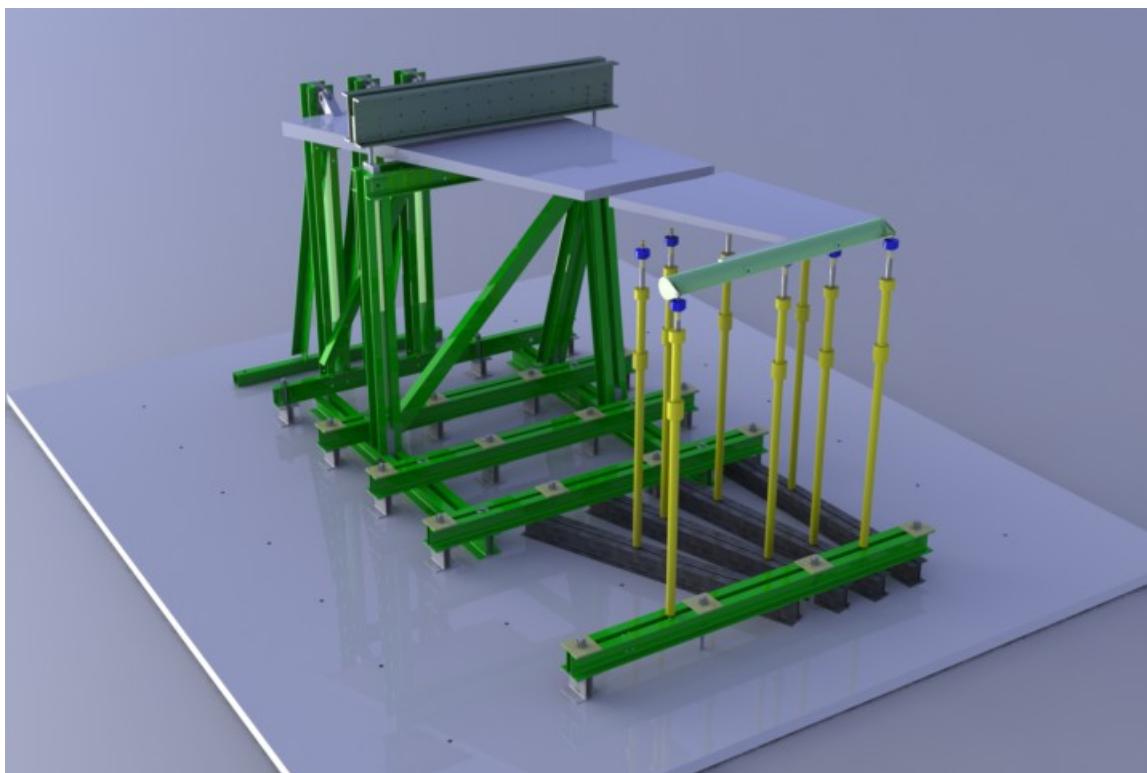
*Figure 1: Design of HOWSAT test rig*

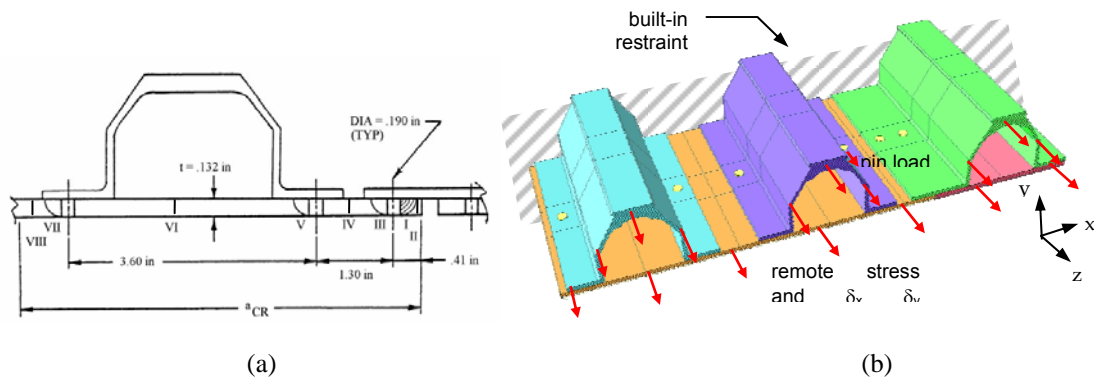
Figure 1: Parametric FEA of CW-5C; (a) location geometry and assumed crack growth phases, (b) solid model with loading and restraints.

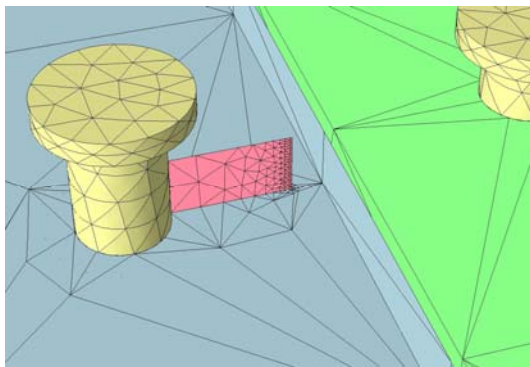
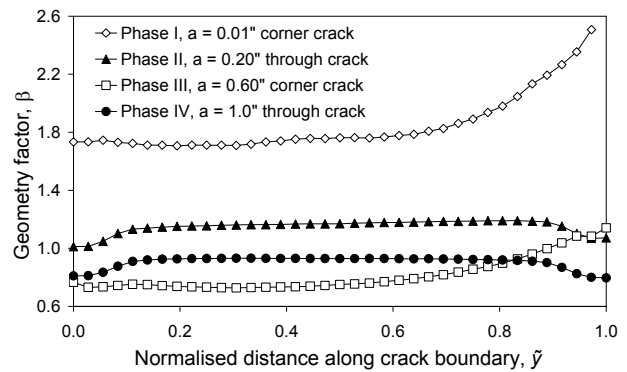
Figure 2: Parametric FEA of CW-5C; (a) localised detail for phase II crack (interior free surfaces), (b) typical beta-factor distribution along crack boundary for remote-loading case.

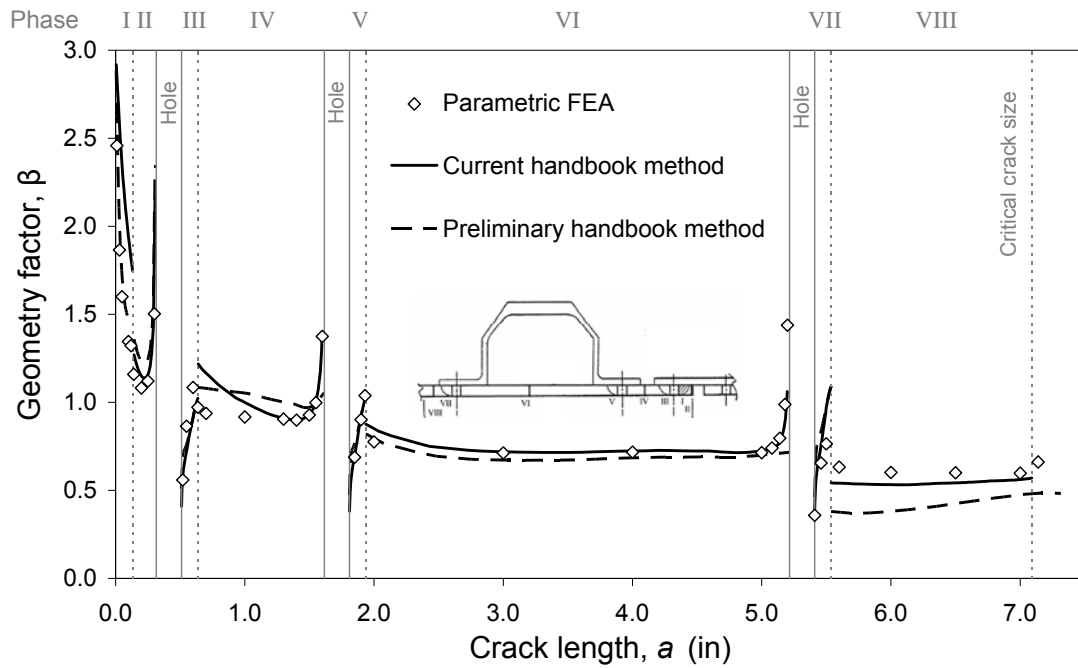
Figure 3: Typical handbook results and comparison with parametric 3D FEA (location CW-5C example, combined pin and remote loading).

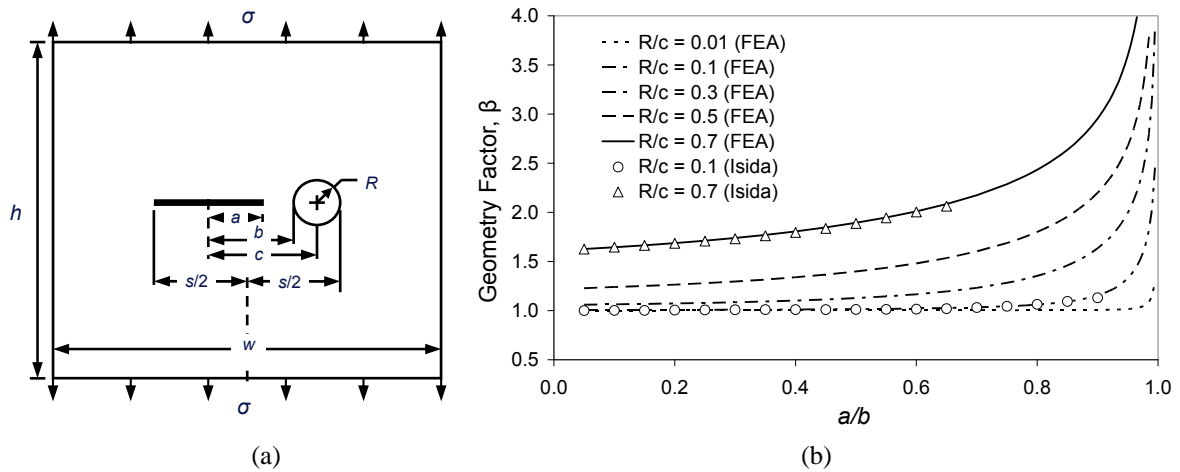
Figure 4: Generic FEA of crack approaching a circular hole; (a) geometry and notation, (b) typical results including comparison with Isida [6].

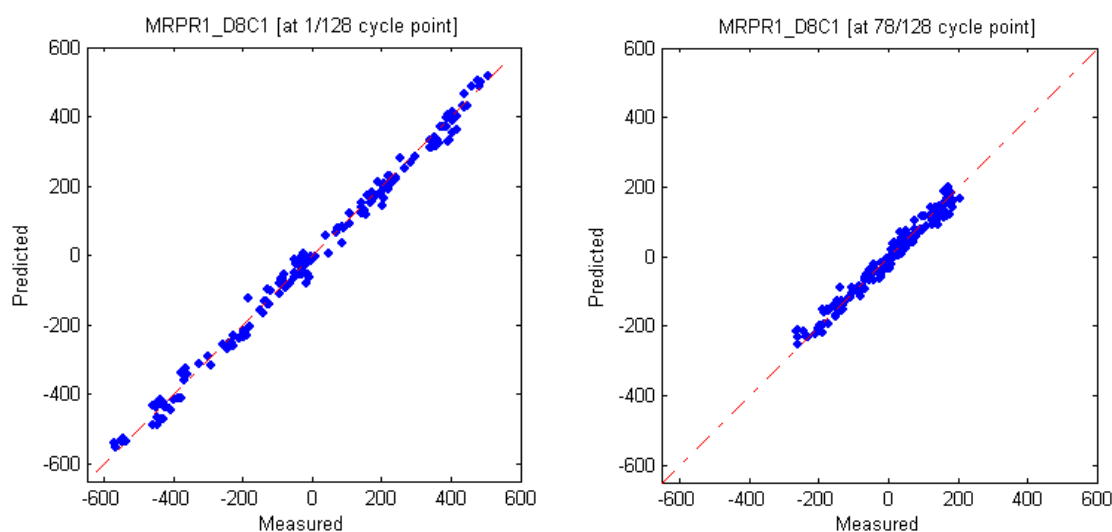
Figure 1: Regression of the Main Rotor Pitch Link loads at 2 azimuth locations using the same 8 stationary component strains and 2 flight parameters as inputs.

The optimization technique performs regressions on all azimuth locations concurrently, selecting only those data channels with the most positive effect on the accuracy of the regression. This minimizes the number of input data channels required and ensures the input data for all azimuth locations is a common set; greatly improving the practicality of the method. Regression results of 2 azimuth locations using the same input channels are shown in Figure 1.

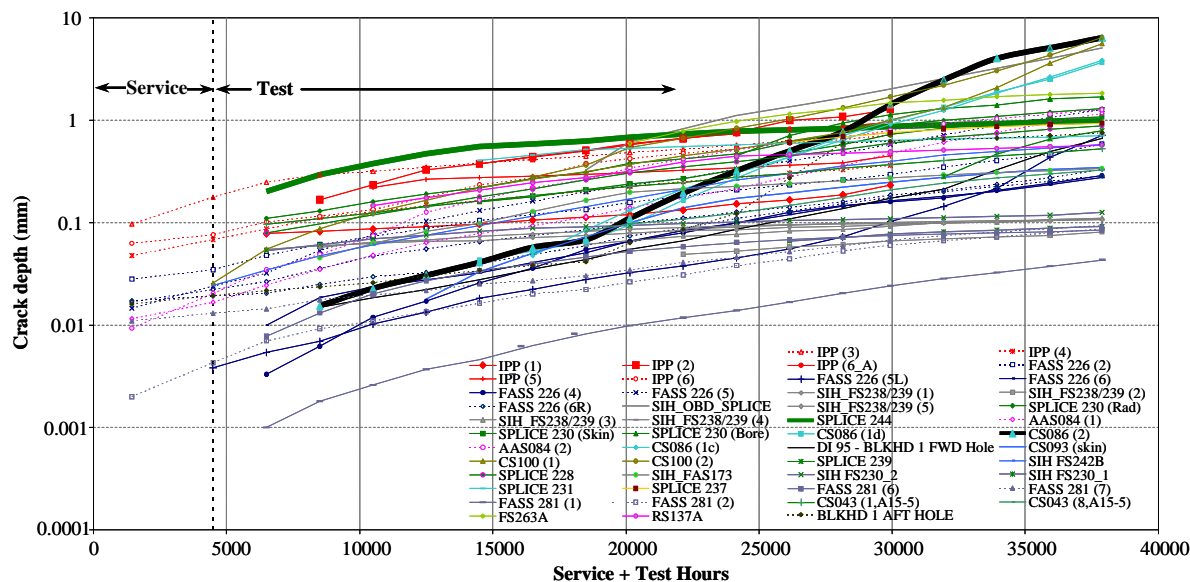
Figure 1: Sample of FCG curves from different locations in the aluminium alloy (AA) 2024-T851 lower wing skin of an F-111 test article removed from service [2]. CS = central spar, BLKHD = bulkhead, FASS = Forward Auxiliary Spar Station inches, IPP = Inner Pivoting Pylon, RS = Rear Spar.

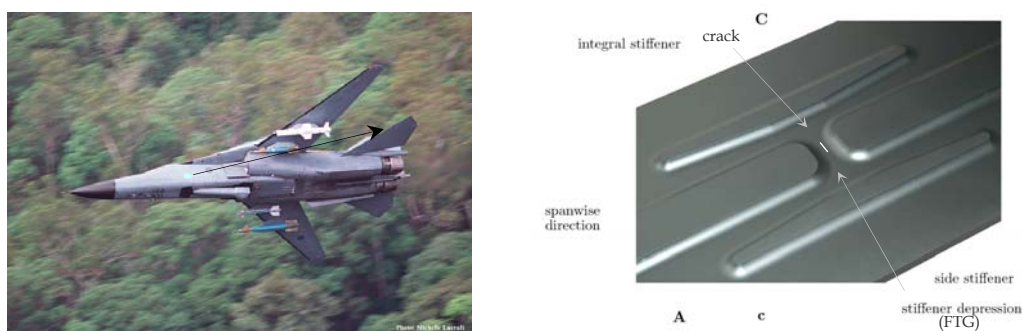
Figure 1: Location of cracking in F-111 LWS (left). Internal view of F-111 LWS around the FTG (right)

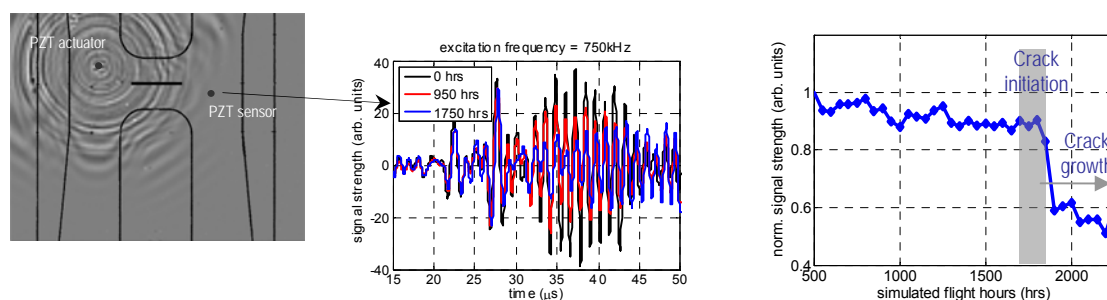
Figure 2: Typical AU response from PZT actuator on the F-111 LWS panel: left - 'snapshot' of surface displacements; middle - time history response of PZT sensor, right - variation in PZT sensor signal strength with increasing load spectrum.

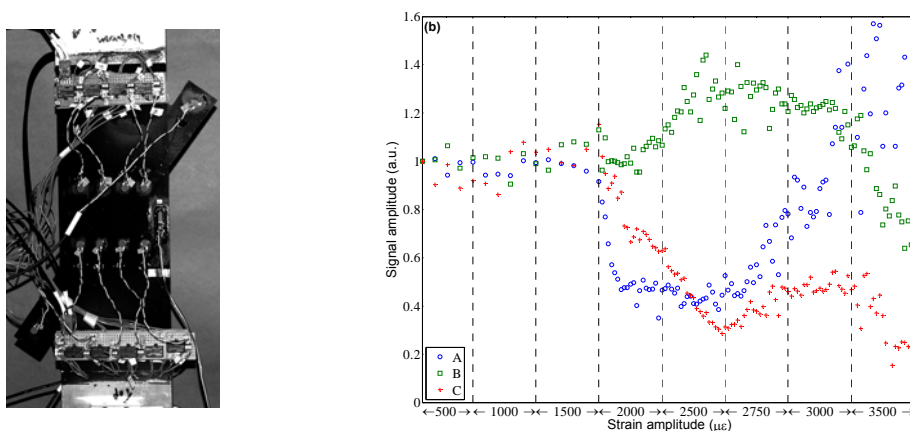
Figure 3: Left - Photograph of specimen showing transducers and switching circuitry required to take impedance and acoustic response measurements. Eight transducers are shown within the load path of the specimen and two reference transducers outside the load path on the 'winged' arms of the specimen. Right - Maximum amplitude of the Hilbert transformation calculated from the FFT of the AU response for three transducers at each of the strain amplitudes indicated.

Transducer durability studies were undertaken using a specimen geometry that allows reference transducers to be placed in a load-free zone, so as to provide a stable reference against which bonded transducers that are exposed to mechanical loads can be assessed (see Figure 3). An initial study was undertaken on a piezoceramic transducer package developed by DSTO and local industry [3, 5, 6]. Transducers were subject to constant amplitude sinusoidal loading, at a stress ratio of 0.1, for strain amplitudes between 500 to 3500  $\mu\epsilon$  (i.e. peak strain of 1100 to 7700  $\mu\epsilon$ ). The response to a stable acoustic wave field (from a reference actuator) changed significantly as transducers were exposed to long term, high strain cycling. For the transducers tested here, loading above a peak strain of 3300  $\mu\epsilon$  produced complex behaviour associated with degradation of the transducer package (Figure 3). It is important to note that degradation, either in the bondline or the transducer itself, does not always lead to a decline in the piezoelectric signal. Overall, an impedance spectrum measurement appeared to be the most reliable in revealing the presence of damage in a transducer. Displacement mapping using a laser vibrometer also proved effective and can provide a quantitative measure of the extent of disbonding under surface-mounted piezoceramic transducers.

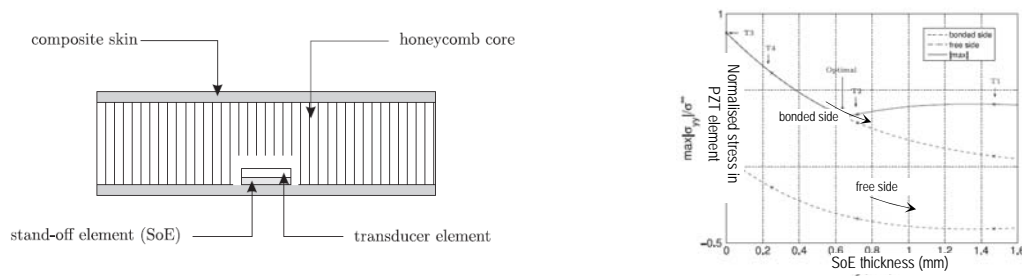
Figure 4: Schematic showing the SoE scheme (left). Predicted reductions in PZT stress with SoE thickness (right)

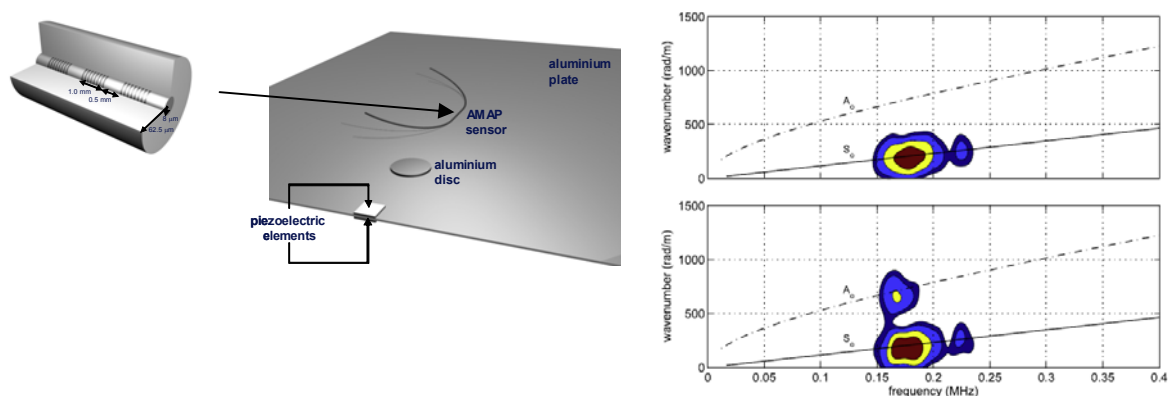
Figure 5: Schematic showing AMAP sensor approach (left) and results for an AMAP sensor on an aluminium plate, without (top right) and with (bottom right) the aluminium disc.

Optical fibres provide a number of advantages for structural interrogation, including: an immunity to electromagnetic interference, excellent mechanical and environmental durability, the capacity for dense sensor multiplexing, ease of embedment in composite materials, reduced wiring requirements and reduced weight. Optical fibre Bragg gratings (FBG) allow the incorporation of a large number of discrete dynamic strain sensors on a single fibre. A spatially distributed array of FBGs offer significant temporal and spatial information allowing the decomposition of structural plate wave modes which is not possible with piezoelectric receiver arrays [6]. This novel approach was demonstrated by DSTO using a prototype acoustic mode assessment photonic (AMAP) sensor. This was an optical fibre sensor comprising an array of 14 uniformly distributed one mm long Bragg gratings with a centre spacing of 1.5 mm, see Figure 5. To assess this approach an AMAP sensor and PZT elements were installed on an aluminium plate. In this case a small thick aluminium disc was bonded to the panel to produce a structural inhomogeneity in the wave path to simulate damage (see Figure 5). This study focused on symmetric Lamb waves ( $S_0$ ) generated by surface-bonded PZT elements. The sensor measurements were acquired without (baseline) and with the disc, and were then compared with theoretical dispersion curves for the plate for both conditions. The insertion of the disc caused wavemode conversion from the symmetric ( $S_0$ ) to the antisymmetric ( $A_0$ ) modes, which were measured by the AMAP sensor (see right hand figures in Figure 5).

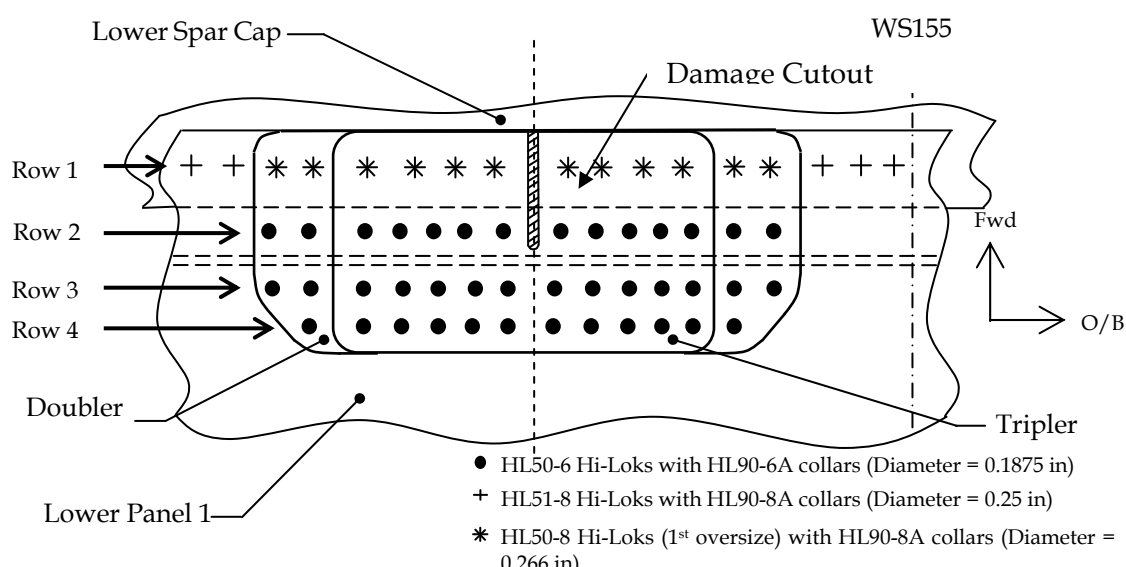
Figure 1: Example Repair for RAM Analysis

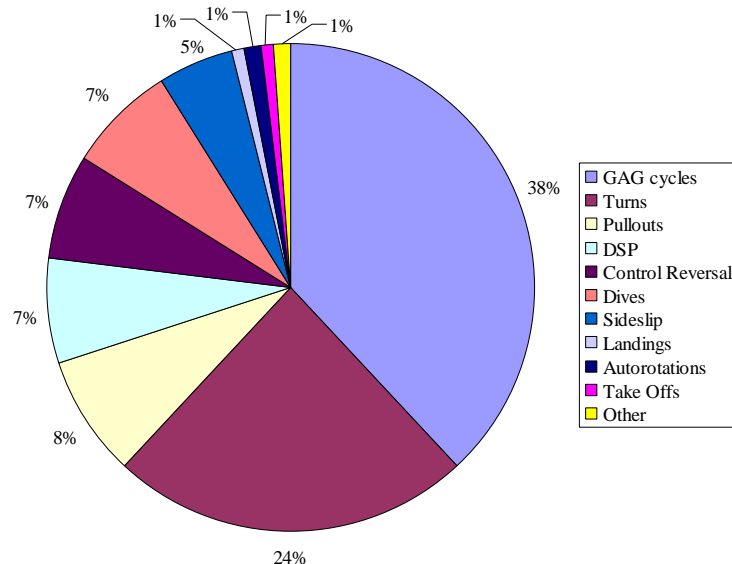
Figure 1: S-70A-9 Black Hawk Critical Structure Fatigue Damage Drivers

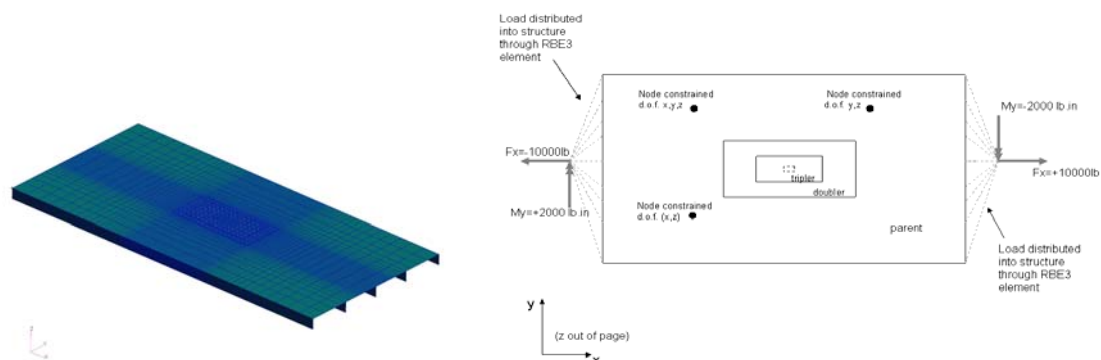
Figure 1: Finite Element Model of Test Problem for the Study

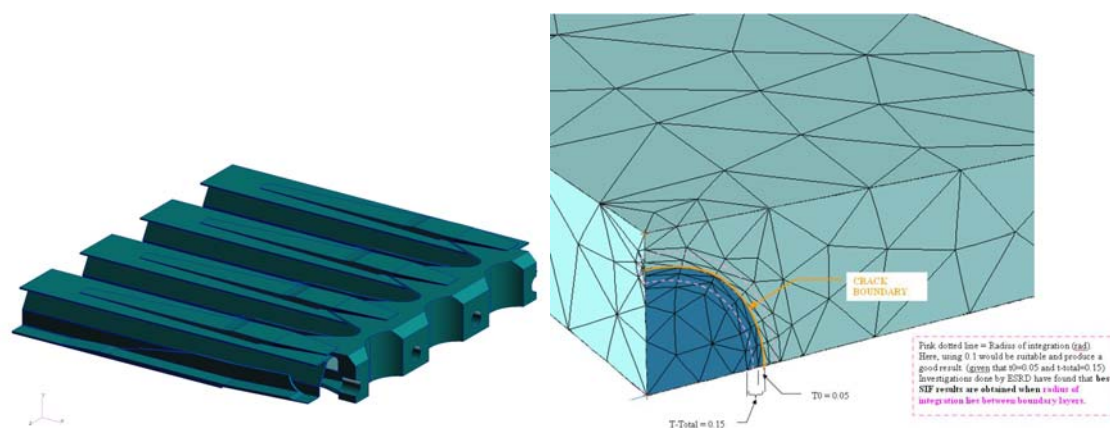
Figure 1: Finite Element and Stress Check Modelling of Cracked Tangs

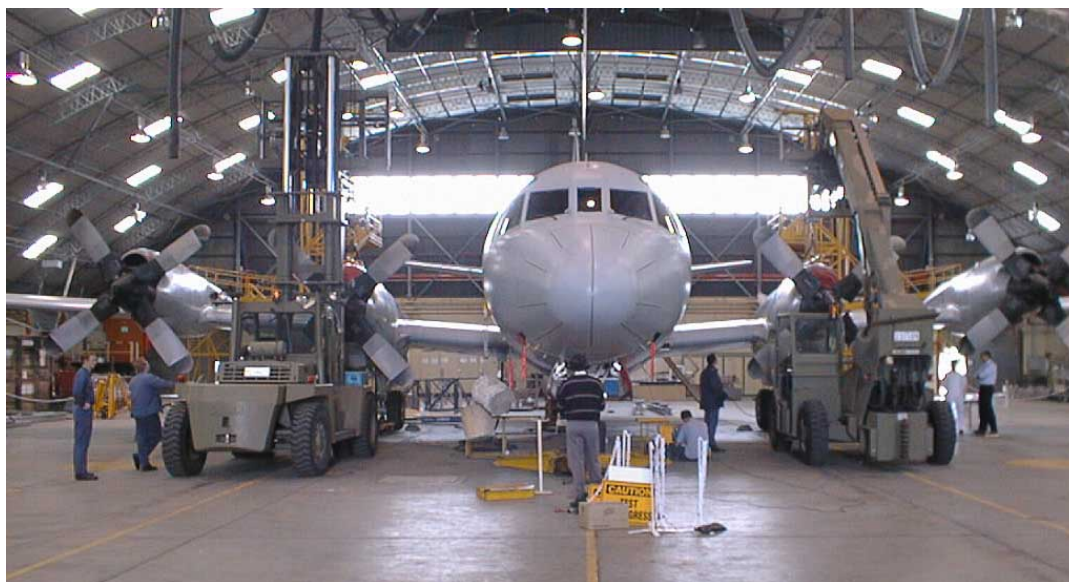
Figure 1: RAAF AP-3C in preparation for OLMS calibration

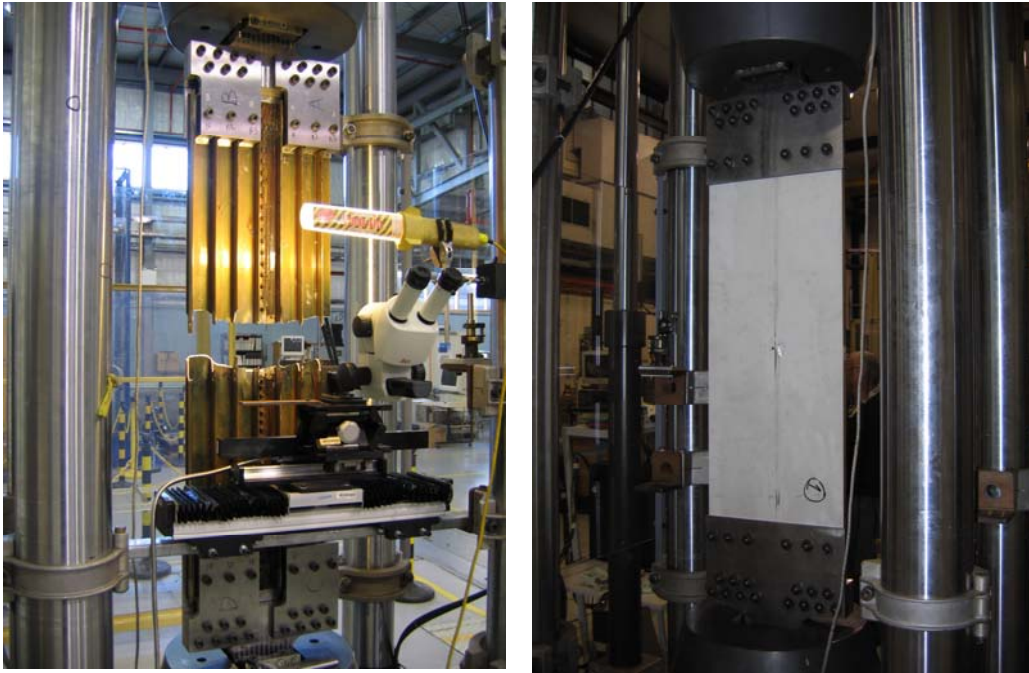
Figure 2: Wing span-wise splice panel component test set-up

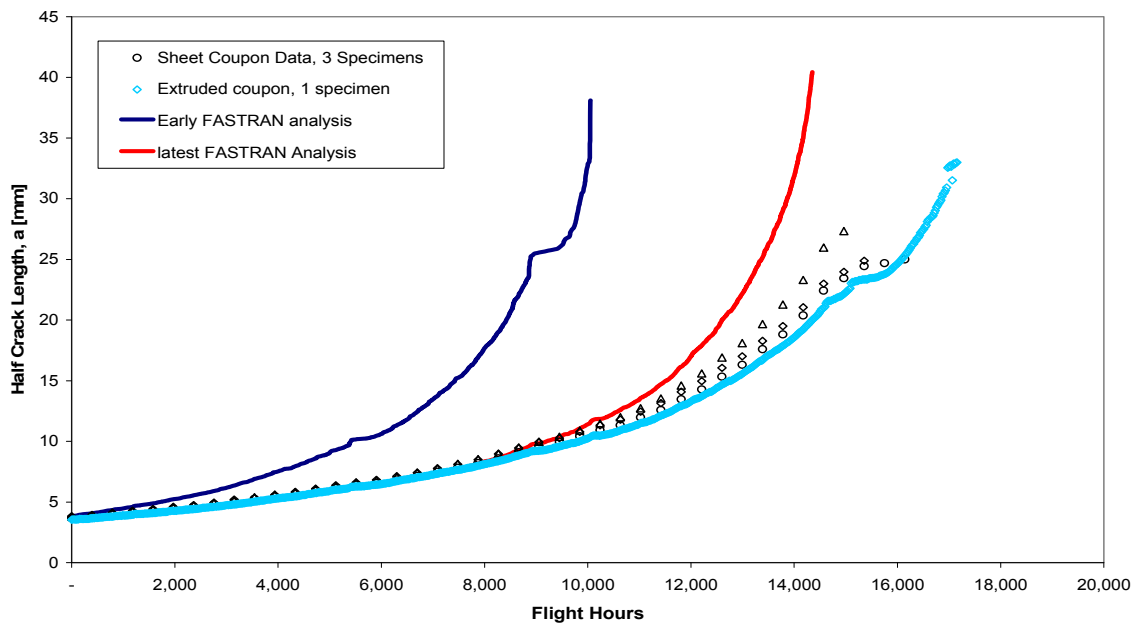
Figure 3: Comparison between analysis and test for centre crack coupons for a typical lower wing location

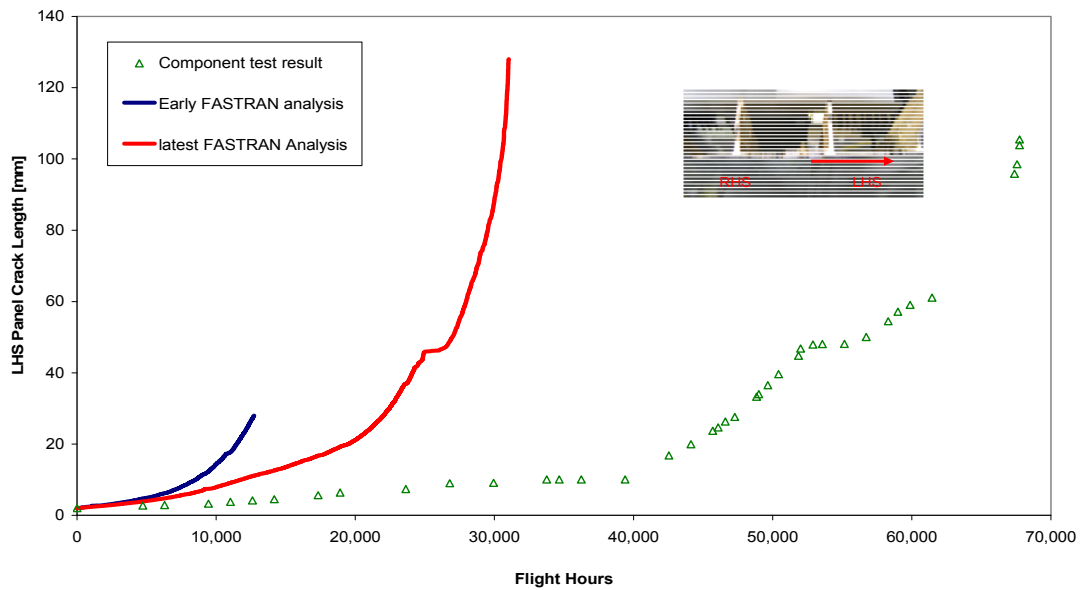
Figure 4: Comparison between analysis and test for spanwise splice component for the same typical lower wing location

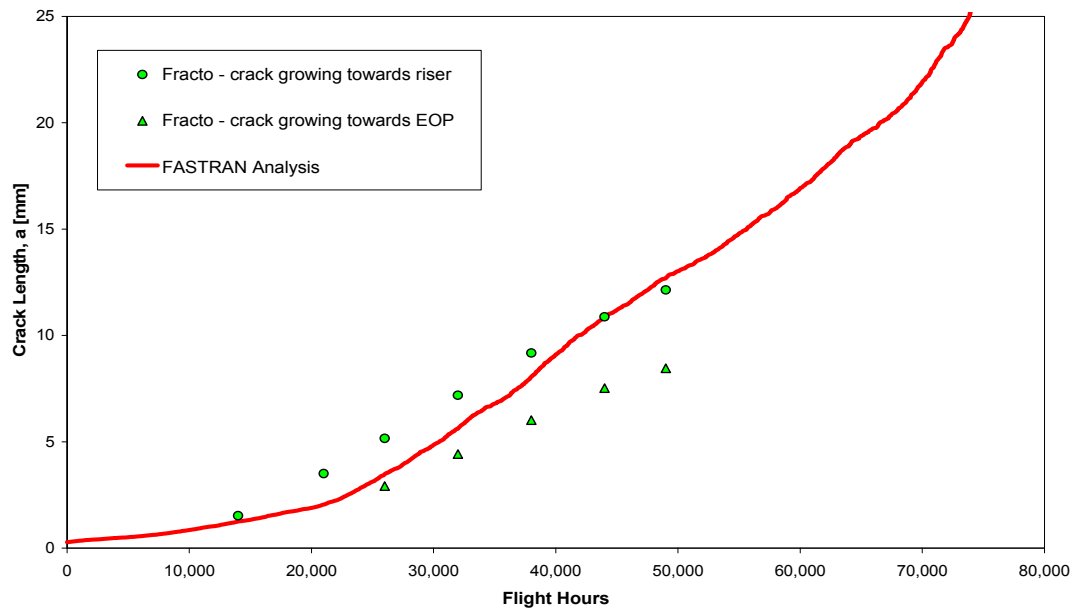
Figure 5: Comparison between analysis and test results for the same wing location from the Full Scale Fatigue Test

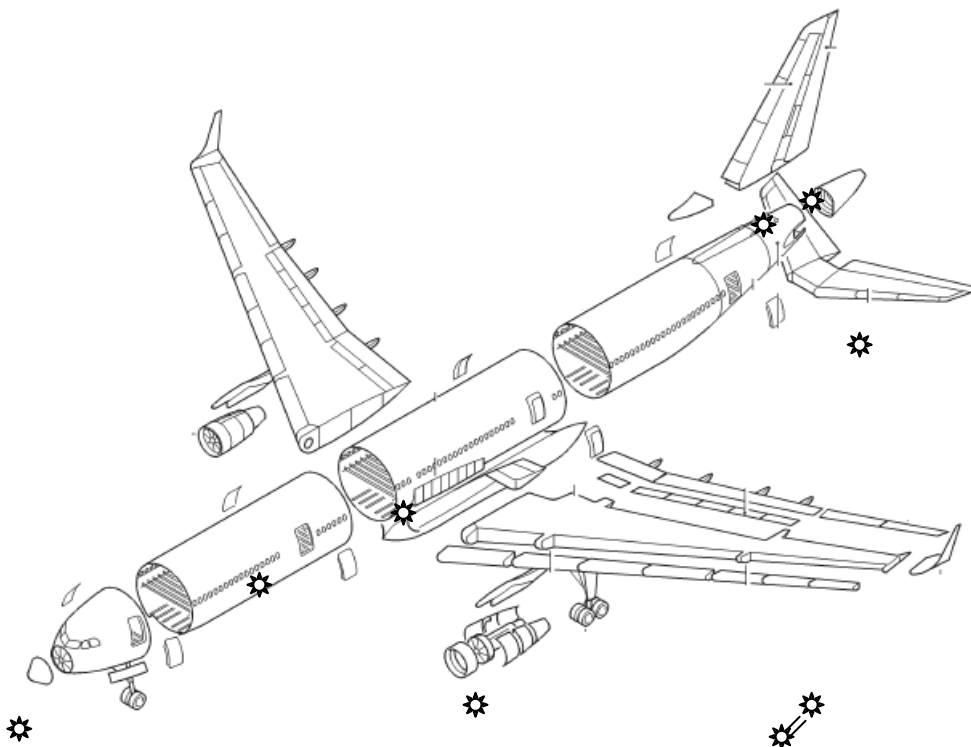
Figure 1: A Few Sample Locations of the Stress Generation Points

- **Validation of Transfer Function Calculation:** validating the transfer function by assessing the correlation of the ANN produced spectrum at the stress generation points shown in Figure 1 and the strain data for the same flight. If the discrepancies fall outside an appropriate error margin, the transfer functions would need to be redefined.

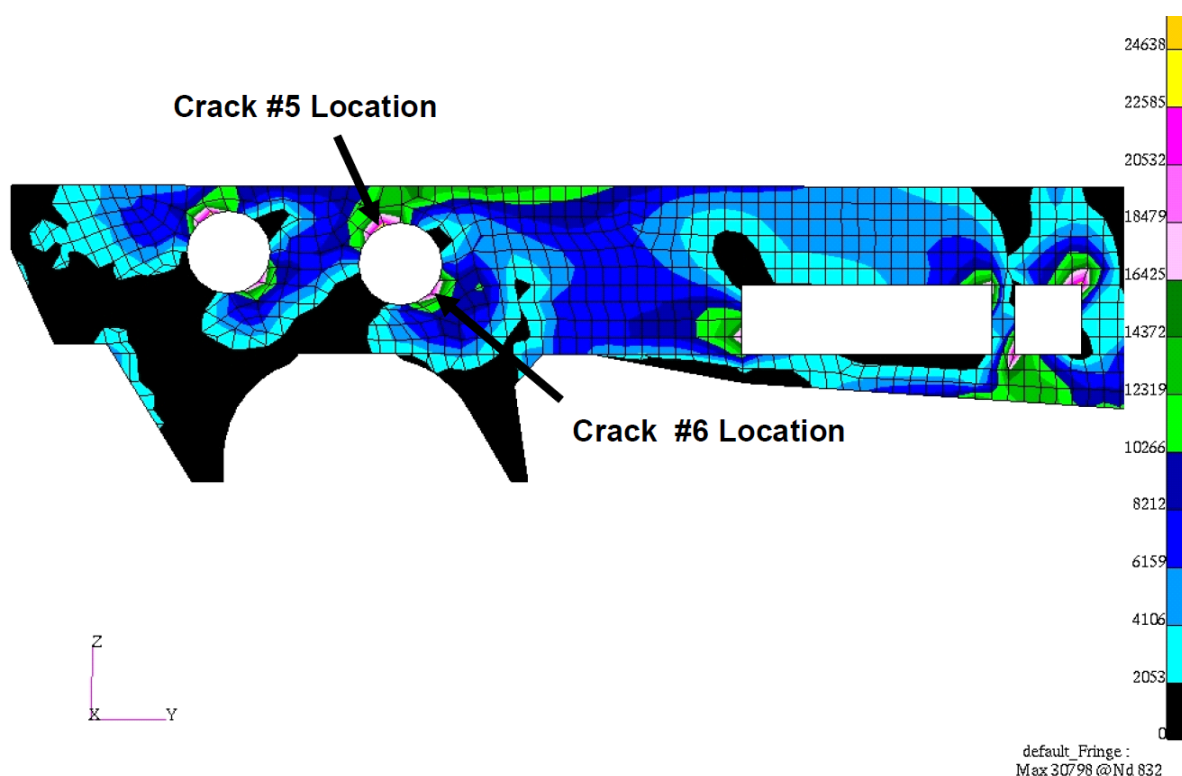
Figure 1: Site location with plot of major principal stress(psi)

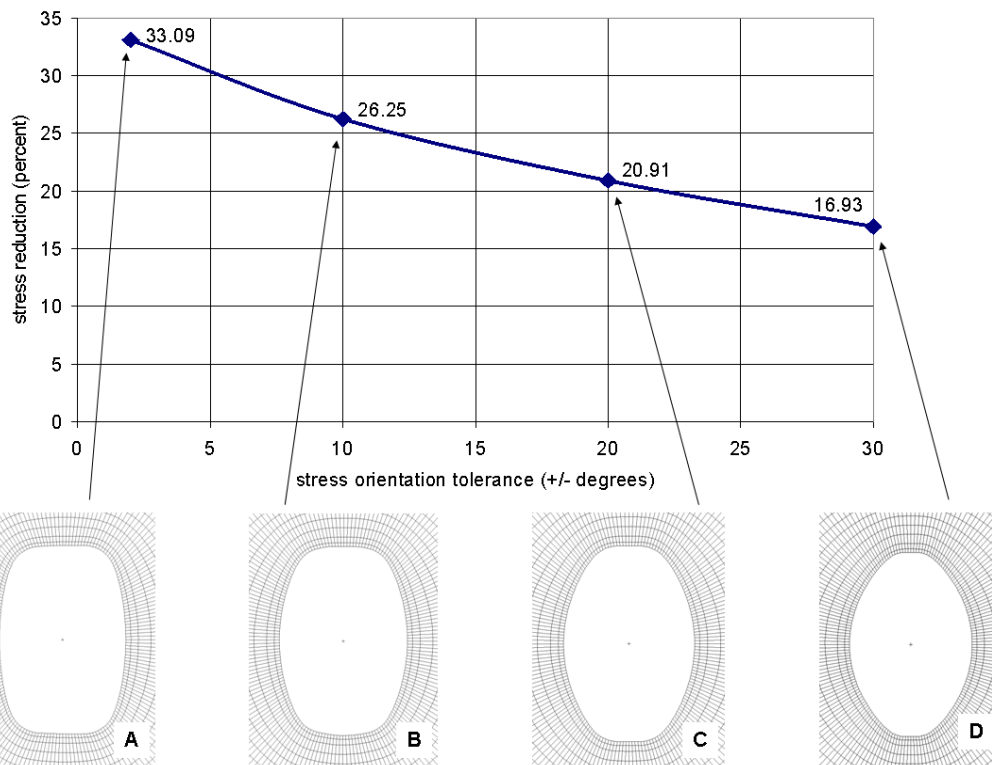
Figure 2: Final hole shapes with stress reductions

Adaptive shape optimisation principals have been used to develop rework shapes for the above circular web penetration (2<sup>nd</sup> from left). The core of the method involves small hole boundary movements using iterative finite element solutions. The boundary remains smooth with accurate boundary stresses used at each iteration to move the boundary outwards from the centre by small amounts inversely proportional to the boundary stress magnitude. A minimum radius of curvature is applied as well as multiple load cases at a range of stress orientations so that the final hole shape is not compromised by small errors in stress orientation. The final shape is not sensitive to stress magnitude. Reductions of 17 – 33% in peak boundary stress have been achieved.

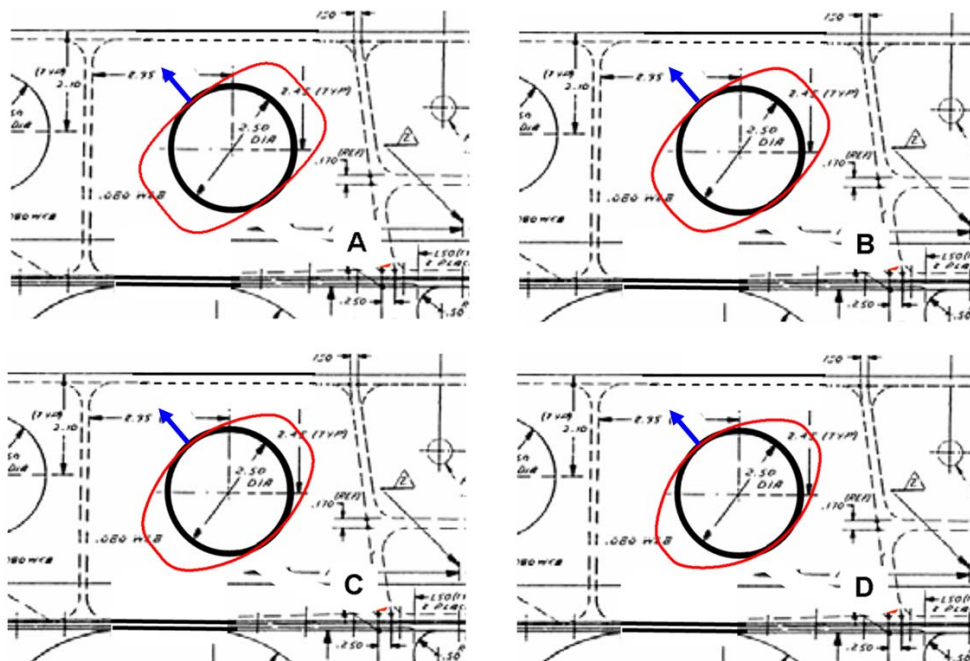
Figure 3: Final hole shapes shown with surrounding structure

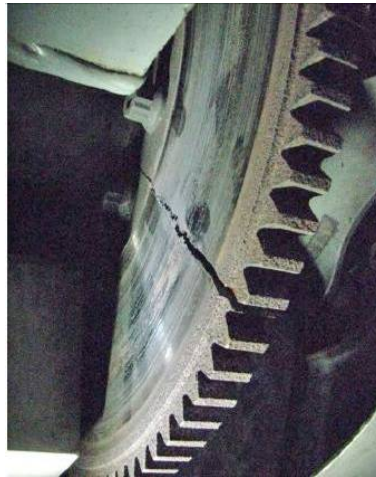
Figure 1: Cracked Main Rotor brake disc in-situ

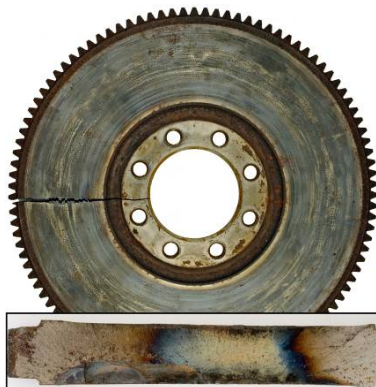
Figure 2: Fracture surface was tinted and corroded. A semi-elliptical crack was present towards the outer diameter of the disc

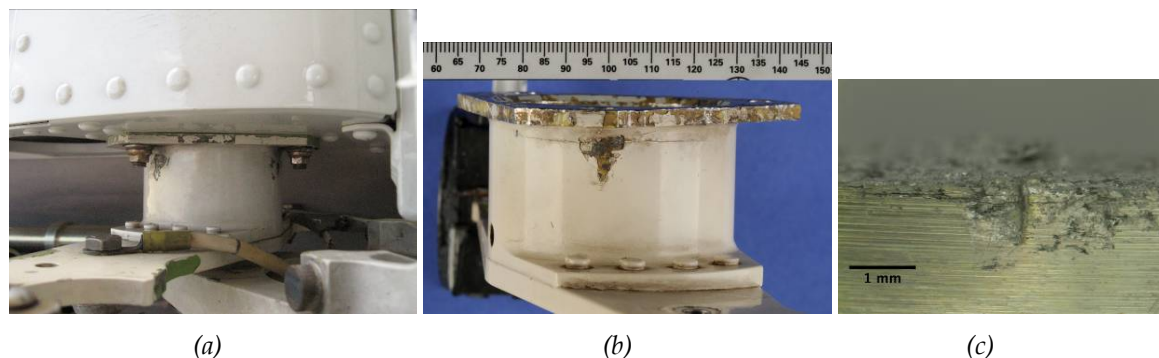
Figure 3: (a) Severe mechanical damage adjacent to the fastener nut, (b) Photograph showing the crack below the attachment point of the torque tube flange and (c) close up view showing multiple crack planes extending from the corrosion pitting

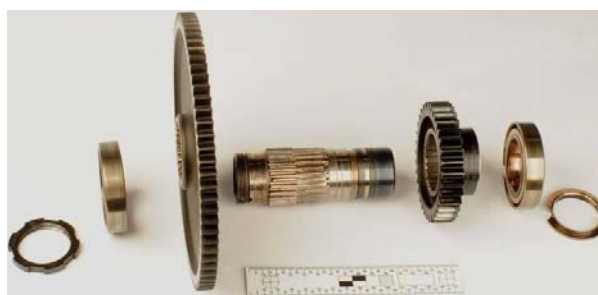
Figure 4: Photograph providing an exploded view of the Alternator Drive Assembly

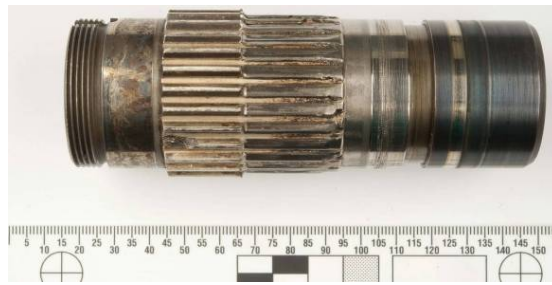
Figure 5: Photograph of the alternator drive shaft assembly showing the heavily worn external splines

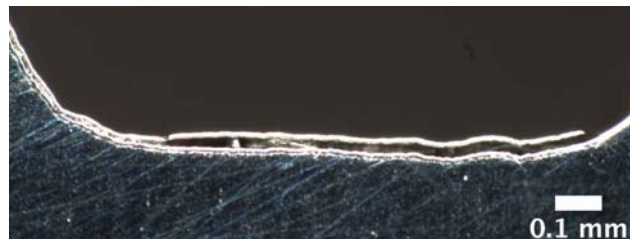
Figure 6: Photograph providing an example of the exfoliated silver flash observed at the root of the alternator drive shaft external spline

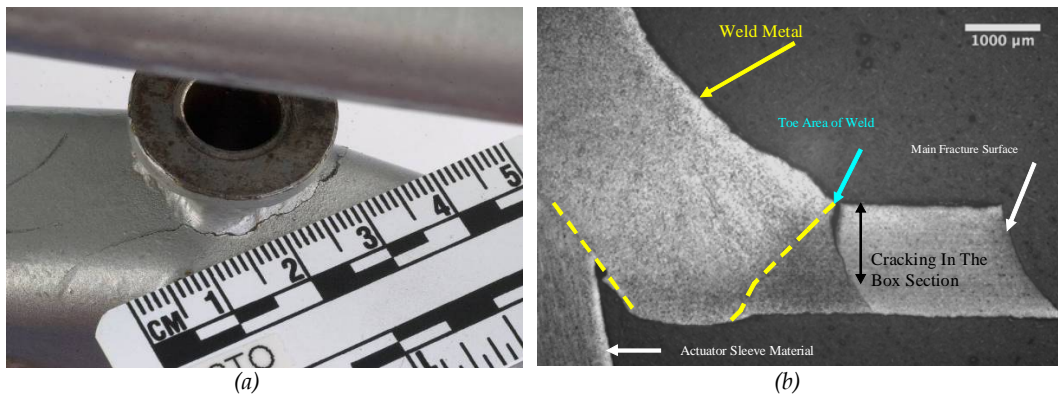
Figure 7: a) crack at the toe of the actuator support sleeve weld and continuing into the box section and b) Photomicrograph of the weld and plate material showing the secondary crack that had also initiated at the toe of the weld and progressed partially through the box section material

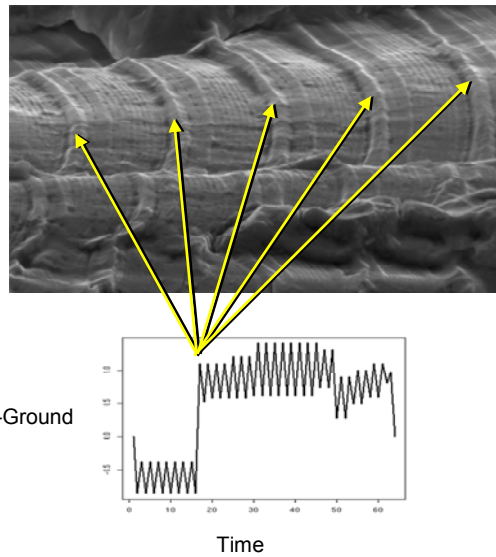
Figure 1: An example of easy to read marks on the fracture surface from applying GAG cycles.

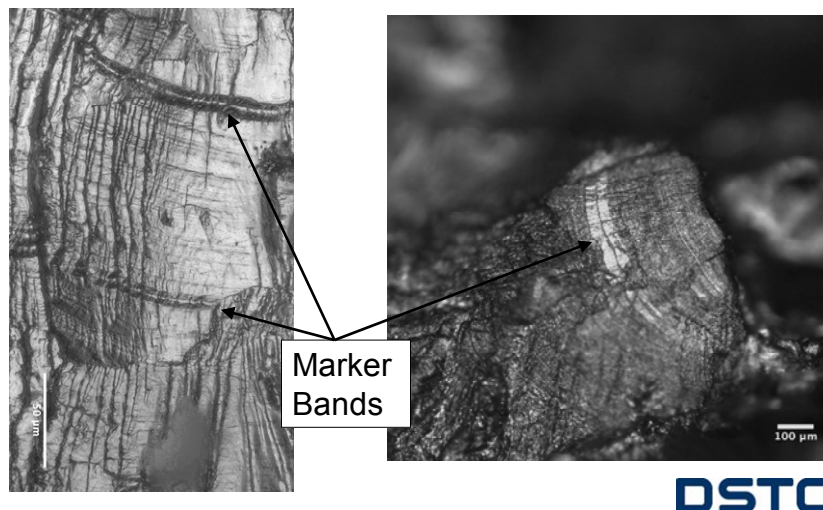
Figure 2: Marker Bands shown on typical combat aircraft Aluminium and Titanium alloys

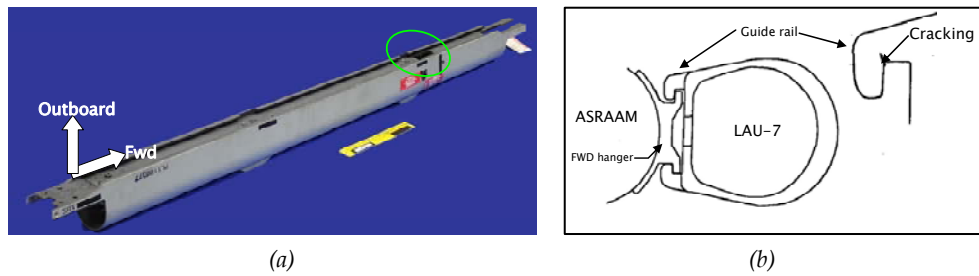
Figure 1: LAU-7 missile launcher (a) complete and (b) cross-section with crack location

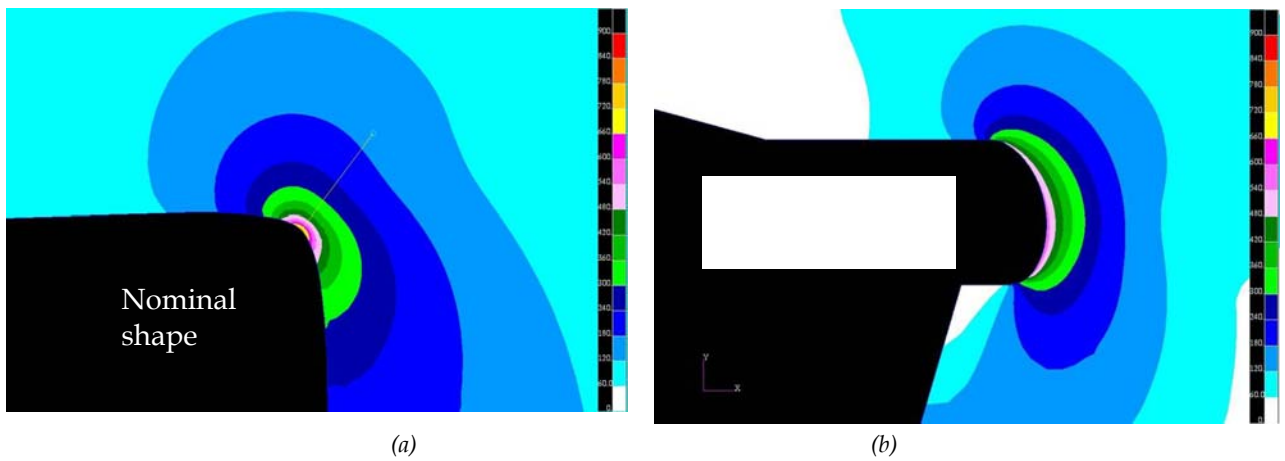
Figure 2: Shape and stress distribution for (a) the nominal geometry and (b) the 1.1 mm deep rework

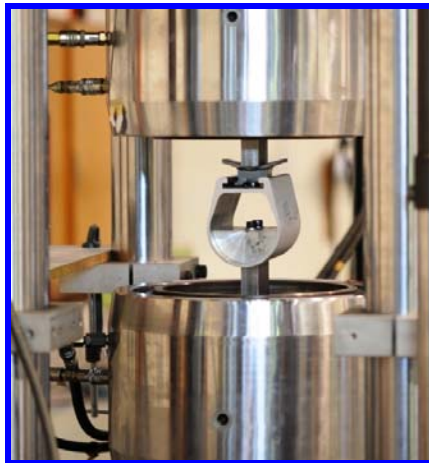
Figure 3: Fatigue test coupon in test machine
